**Flood Control Project Maintenance
Levee Inspections**

Fall 2016 Levee Maintenance Deficiency Summary Report

Reclamation District No. 0349 Sutter Island

Fall 2016 Levee Inspection Results

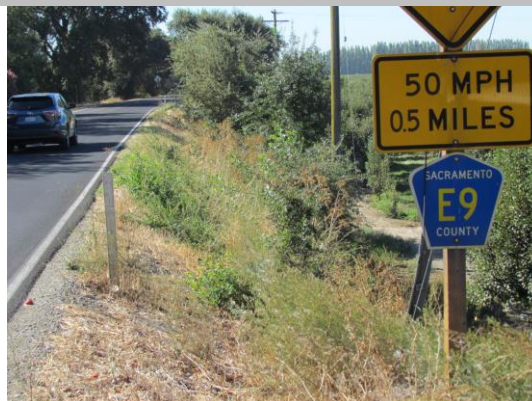
Photo 1 of 1 : FA_2016_RD0349_204_15_20161003_00023.jpg

LM Start	0.00	Rating **	U	Issue No.	15
LM End	0.99	Issue Type +	Ma	Location *	LS
Category	Earthen Levee			GPS Latitude/Longitude	
				Start	End
Item	Vegetation			38.327148 °	38.313078 °
				-121.576952 °	-121.578780 °
DWR ID	DWR_RD0349_01_f_2016_15				
Comment Code					
V1 : Control annual grass and weeds on the levee slopes and easements.					
Inspector Comment					
Control the wild growth of vegetation on the landside levee slope.

RD 349 Unit 1 landside looking downstream at levee slope.

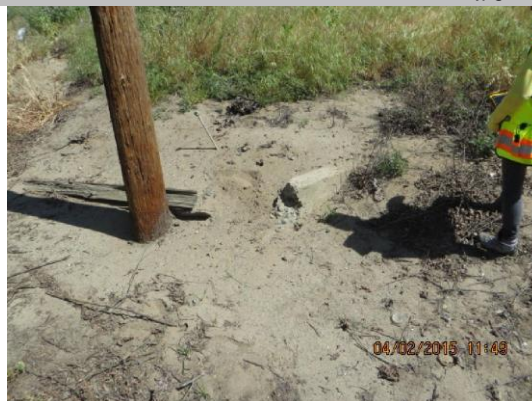
Photo 1 of 2 : UCIP_FA_2016_44303_73622.jpg

Comment Code						
Inspector Comment						
FS_ID:44303						
DS_ID:24137						
EP_NO: N/A						
Repair Type: Non-Urgent						
Crossing Status: Indicator Found						
UCIP Comments: Pipe appears to be abandoned and if so should be done so properly. Electromagnetic survey indicated a crossing at this location.						
FIELD_STRUCT_DESC: *ABANDONED* 10-inch pipe through the levee, 3.8 feet below the crown. Power pole and anchor on the landward side. Deteriorated concrete box at the LS toe. Concrete debris on WS toe good indicator of pump location (USACE-1960). This entry matches the Drainage or Irrigation Structure referenced in O&M manual (HLM 2.74).						
FS Date: 4/2/2015

Deteriated concrete distribution box on LS toe next to power pole.

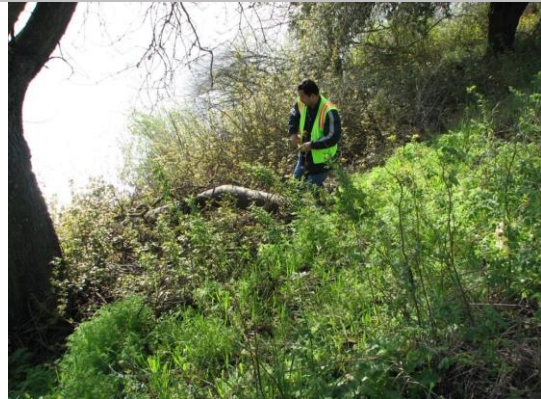
Photo 1 of 2 : UCIP_FA_2016_21572_36576.jpg

FS_ID:21572
DS_ID:24521
EP_NO: N/A
Repair Type: Non-Urgent
Crossing Status: Found
UCIP Comments: No records were found during initial desk study--need to contact owner to obtain permit number authorizing work. If crossing is no longer used by owner, the owner will need to coordinate with DWR Inspector and CVFPB to remove crossing according to Title 23 requirements. Dense vegetation limits the inspector's visibility to identify signs of pipe failure (leaks) along the slope. Recommend removing vegetation along pipe alignment to conduct proper inspection of structure and appurtenances. Note date on photos should be 3/18/09 not 7/26/08 camera metadata is incorrect.
FIELD_STRUCT_DESC: *ABANDONED* 8-inch pipe through the levee, 13.9 feet below the crown. Pump on platform at landward toe. Service pole on landward slope.
FS Date: 3/18/2009

View of pipe crossing located on waterward side--dense vegetation on levee slope.

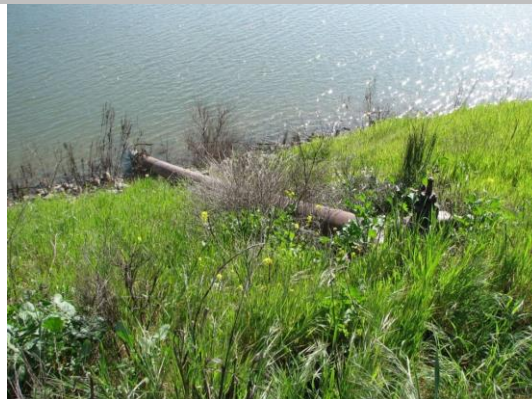
Photo 1 of 2 : UCIP_FA_2016_50013_36561.jpg

FS_ID:50013
DS_ID:24140
EP_NO: N/A
Repair Type: Non-Urgent
Crossing Status: Found
UCIP Comments: 8/22/2016 Crossing has been downgraded from Urgent to Non-Urgent no signs of pipe failure were visible during site inspection. Minor erosion visible on LS shoulder covered by dry leaves. No permit was found--need to contact owner to determine age of crossing and determine when the last internal inspection was completed. (DWR UCIP - omagana)8/13/2009 Exposed section of levee slope on LS--need to contact owner and DWR inspector. Dense vegetation limits the inspector's visibility to identify signs of pipe failure (leaks) along the slope. Recommend removing vegetation along pipe alignment to conduct proper inspection of structure and appurtenances. Note date on photos should be 3/18/09 not 7/26/08 camera metadata is incorrect. (DWR UCIP - omagana)
FIELD_STRUCT_DESC: 14-inch pipe (waterside (WS) shoulder) and 12-inch pipe (landside (LS) shoulder) through the levee, 4.7 feet below the crown. Gate valve on the WS slope. Pump in pumphouse on LS slope. Pressure breaker behind pumphouse. Pipe exposed on WS slope. [Additional Reference(s): DWR Levee Log, 2005. USACE San Joaquin O&M Manual Unit No. 110, May 1959, HLM 1.1]

View of pipe on WS.

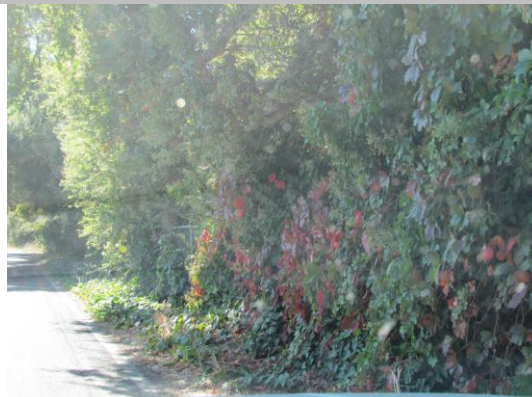
Photo 1 of 1 : FA_2016_RD0349_204_16_20161003_00025.jpg

LM Start	1.06	Rating **	U	Issue No.	16
LM End	1.24	Issue Type +	En	Location *	LS
Category	Earthen Levee			GPS Latitude/Longitude	
				Start	End
Item	Vegetation			38.311992 °	38.309635 °
				-121.578460 °	-121.577285 °
DWR ID	DWR_RD0349_01_f_2016_16				
Comment Code					
V6 : Landscaping					
Inspector Comment					
The landscaping along levee mile 1.06-1.24 is unmaintained and completely blocking the view of landside levee slope.

RD 349 Unit 1 levee mile 1.06-1.24 unmaintained landscaping

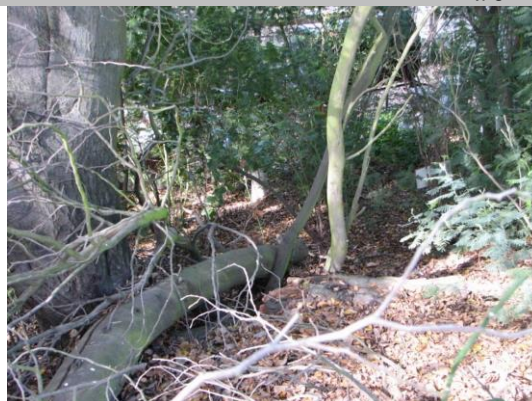
Photo 1 of 2 : UCIP_FA_2016_44214_36572.jpg

FS_ID:44214
DS_ID:24143
EP_NO: 12005
Repair Type: Non-Urgent
Crossing Status: Found
UCIP Comments: Pipe open on WS slope. 2007 Erosion Repair Site location?--Need to contact owner to determine if crossing is still in use. Dense vegetation limits the inspector's visibility to identify signs of pipe failure (leaks) along the slope. Recommend removing vegetation along pipe alignment to conduct proper inspection of structure and appurtenances. Note date on photos should be 3/18/09 not 7/26/08 camera metadata is incorrect.
FIELD_STRUCT_DESC: 6-inch steel irrigation pipe, 4.0 feet below the crown. Siphon breaker and protective housing at levee shoulder. Pump on waterward side. Pipe exposed on waterward slope, extending to pump. Discharge structure at landward toe. (Permit No. 12005-1977)
FS Date: 4/2/2015

View of landward side.

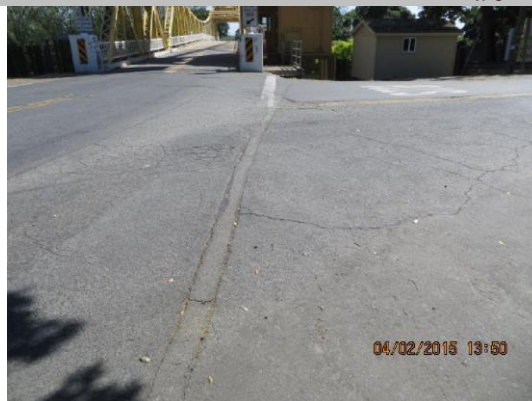
Photo 1 of 2 : UCIP_FA_2016_46168_74542.jpg

FS_ID:46168
DS_ID:25096
EP_NO: N/A
Repair Type: Non-Urgent
Crossing Status: Indicator Found
UCIP Comments: Need to identify permit for crossing.
FIELD_STRUCT_DESC: 2-inch waterline through the levee at an unknown depth below crown. Pipe provides service to bridge and beach (per landowner).
FS Date: 4/9/2015

Cut in pavement good indicator of pipe location.

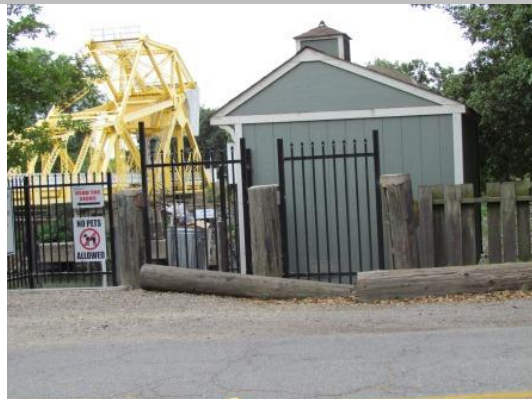
Photo 1 of 2 : FA_2016_RD0349_205_4_20160913_00005.jpg

LM Start	0.01	Rating **	U	Issue No.	4
LM End	0.01	Issue Type +	En	Location *	WS
Category	Earthen Levee			GPS Latitude/Longitude	
				Start	End
Item	Encroachments			38.304870 °	38.304870 °
				121.574730 °	121.574730 °
DWR ID	DWR_RD0349_02_s_2012_4				
Comment Code					
BU : Building					
Inspector Comment					
This encroachment is along the waterward shoulder and was not authorized by the CVFPB. There are multiple encroachments at this site. Owner was working with CVFPB to get permits as of 11-2013. This issue is still pending as of 2016.

Unauthorized building waterside shoulder; Unit 2 Sutter Slough.

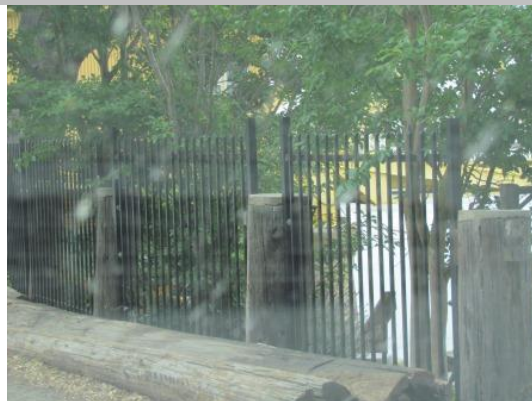
Photo 2 of 2 : FA_2016_RD0349_205_4_20160913_00006.jpg

Unauthorized fence adjacent to building waterside Sutter Slough.

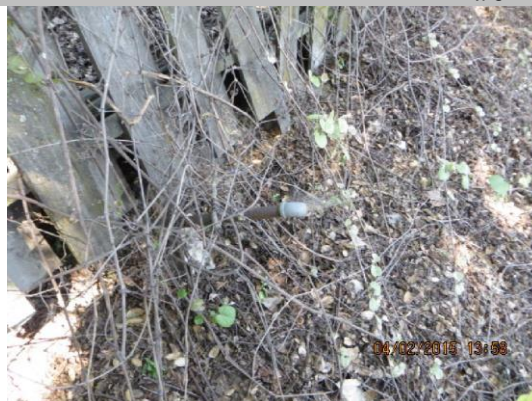
Photo 1 of 2 : UCIP_FA_2016_46169_74545.jpg

FS_ID:46169
DS_ID:25098
EP_NO: N/A
Repair Type: Non-Urgent
Crossing Status: Found
UCIP Comments: Appears abandoned and if so should be done so properly. Need to identify permit.
FIELD_STRUCT_DESC: 1-inch waterline through the levee 1.5-feet below the crown. Pipe visible at fence on WS slope.
FS Date: 4/9/2015

Pipe visible at base of fence on WS shoulder.

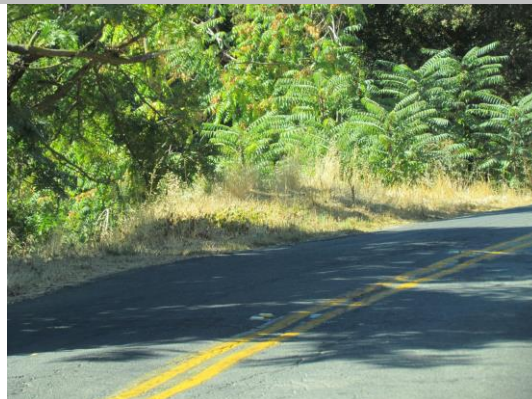
Photo 1 of 1 : FA_2016_RD0349_205_44_20161003_00078.jpg

LM Start	0.05	Rating **	U	Issue No.	44
LM End	0.57	Issue Type +	Ma	Location *	WS
Category	Earthen Levee			GPS Latitude/Longitude	
				Start	End
Item	Vegetation			38.304863 °	38.299367 °
				-121.575475 °	-121.581493 °
DWR ID	DWR_RD0349_02_s_2016_44				
Comment Code					
V2 : Remove the wild growth other than native grasses from the levee slopes.					
Inspector Comment					
Unwanted tall weeds and small trees present on the water side slope need to be removed.

RD349 Unit 2 looking downstream from the waterside shoulder and levee slope.

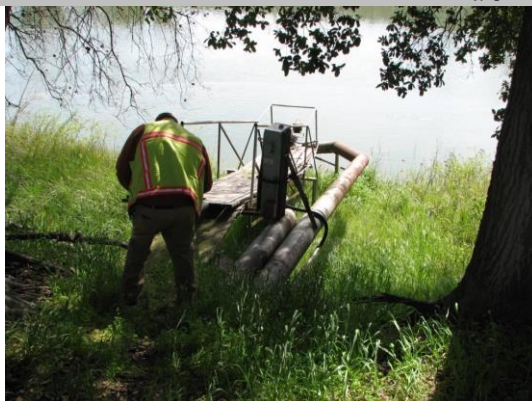
Photo 1 of 2 : UCIP_FA_2016_21577_36597.jpg

Dense vegetation on waterward slope-2 pipes and 1 conduit.

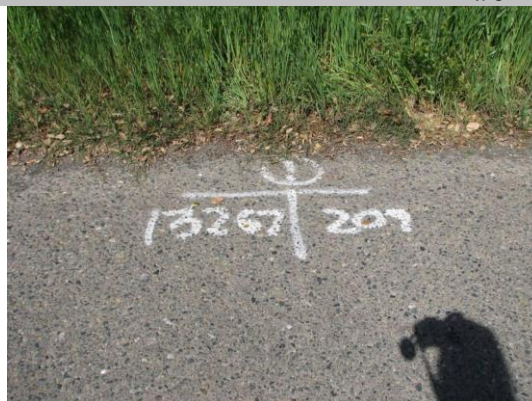
Photo 1 of 2 : UCIP_FA_2016_21613_36685.jpg

Underground service alert (USA) marking on levee crown.

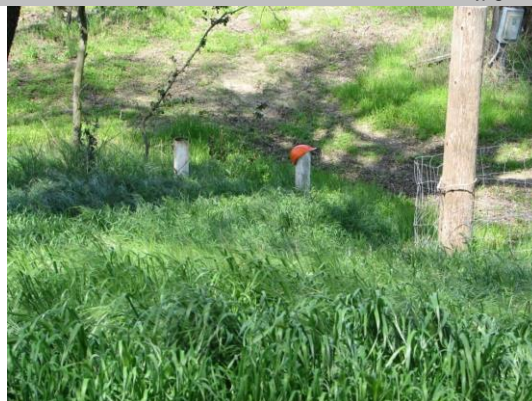
Photo 1 of 2 : UCIP_FA_2016_21614_36691.jpg

View of landward side--unable to inspect.

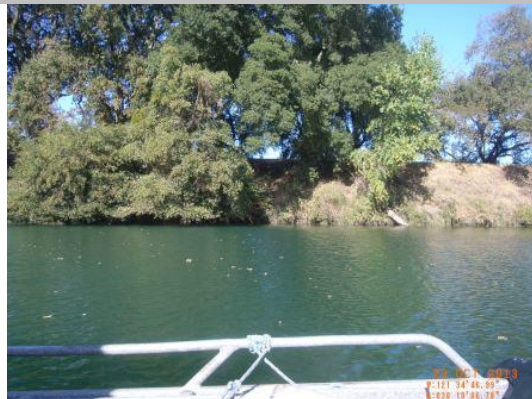
Photo 1 of 1 : FA_2016_RD0349_205_9_20160913_00007.jpg

LM Start	0.34	Rating **	M	Issue No.	9
LM End	0.39	Issue Type +	Ma	Location *	WS
Category	Supplemental			GPS Latitude/Longitude	
				Start	End
Item	2015 USACE Erosion Survey, DRAFT			38.302358 °	38.301772 °
				-121.579707 °	-121.580093 °
DWR ID	DWR_RD0349_02_s_2016_9				
Comment Code					
Inspector Comment					
2007 - Slow erosion, probably due to wave wash and fluvial erosion. Site has likely been here for awhile but was unseen due to boats parked in front. 2015: Large tree popout, scarp reaches crown of levee. [2015 Site ID: STM_25-8_R]

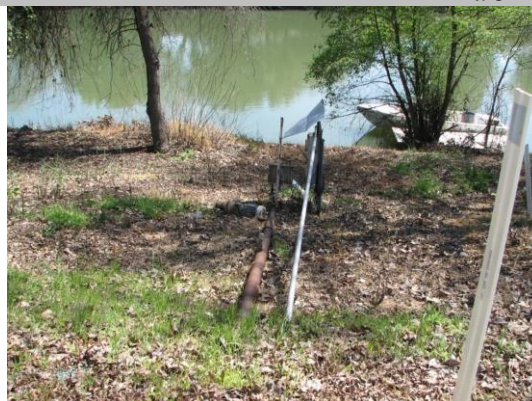
Photo 1 of 2 : UCIP_FA_2016_21615_36694.jpg

View of pipe and pump on waterward side.

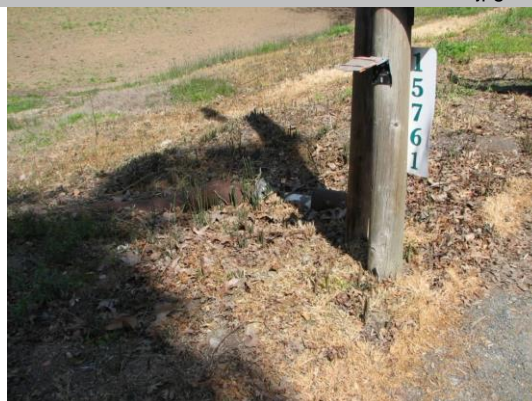
Photo 2 of 2 : UCIP_FA_2016_21615_36695.jpg

View of landard shoulder--service pole and pipe section through slope.

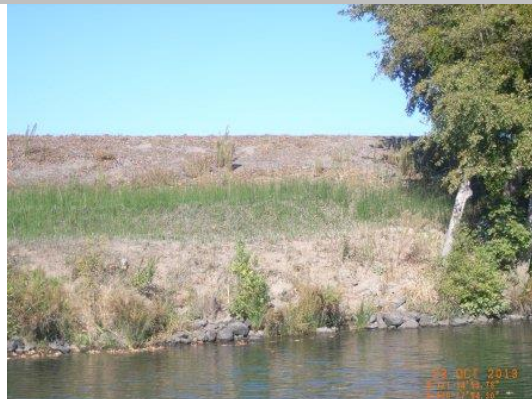
Photo 1 of 1 : FA_2016_RD0349_205_13_20160913_00010.jpg

LM Start	0.60	Rating **	M	Issue No.	13
LM End	0.72	Issue Type +	Ma	Location *	WS
Category	Supplemental			GPS Latitude/Longitude	
				Start	End
Item	2015 USACE Erosion Survey, DRAFT			38.298897 °	38.297384 °
				-121.581571 °	-121.582176 °
DWR ID	DWR_RD0349_02_s_2016_13				
Comment Code					
Inspector Comment					
2010 - Small maintenance, erosion into the toe. 2011 - Minor new erosion at toe. 2015: Minor new erosion at toe, new tree popout. [2015 Site ID: STM_25-5_R]

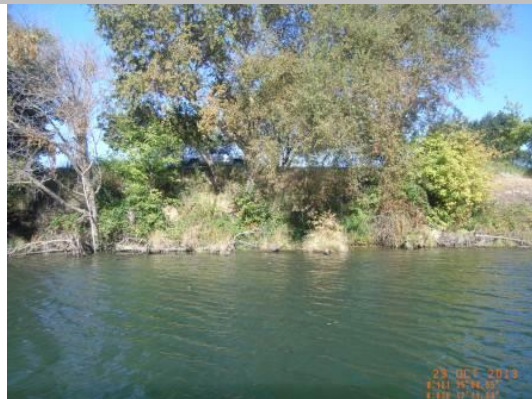
Photo 1 of 1 : FA_2016_RD0349_205_10_20160913_00008.jpg

Comment Code					
Inspector Comment					
1997 - Erosion of very sandy levee behind large stand of riparian vegetation on top right bank. Dry ravel of sand. 1999 - Quarry waste rock was dumped down the levee slope; poor repair job; still eroding in places. Eroding at midslope off fabric. 2005 - Length revised, only the middle 150 - 200 ft are eroding. 2006 - Some rock/small material dumped down the bank but it is slowly unraveling. Upstream end is unraveling faster. Steep slope with poor gradation so fines are washing out. 2010 - Lots of overhanging trees and erosion pockets. 2011 - This site is upgraded to CRITICAL. Near vertical bank at the downstream end. New erosion at various locations throughout the site. 2015: No observed changes. [2015 Site ID: STM_24-7_R]

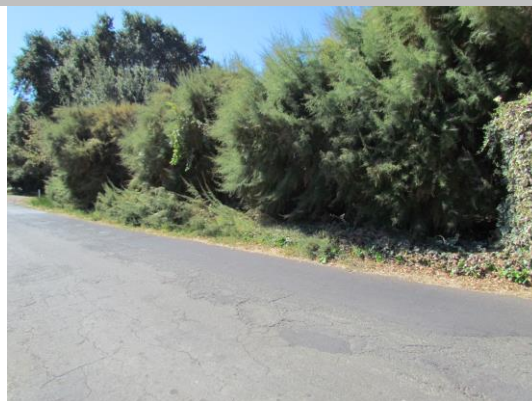
Photo 1 of 1 : FA_2016_RD0349_205_56_20161003_00089.jpg

LM Start	1.33	Rating **	U	Issue No.	56
LM End	2.36	Issue Type +	Ma	Location *	LS
Category	Earthen Levee			GPS Latitude/Longitude	
				Start	End
Item	Vegetation			38.288718 °	38.275795 °
				-121.584042 °	-121.591430 °
DWR ID	DWR_RD0349_02_s_2016_56				
Comment Code					
V7 : Trees / Woody Vegetation					
Inspector Comment					
Remove this unwanted woody tree growth and wild vegetation from the levee slope landward.

Looking downstream from levee mile 1.33 to 2.36.

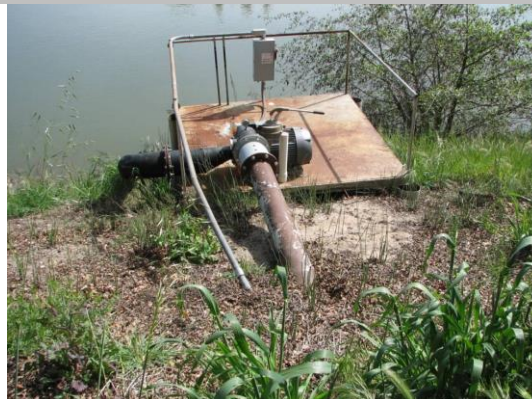
Photo 1 of 2 : UCIP_FA_2016_21607_36661.jpg

View of waterward side.

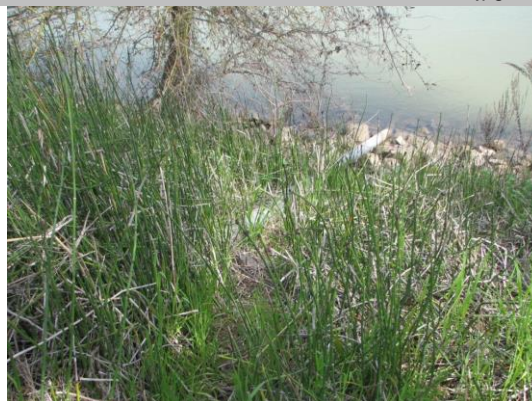
Photo 1 of 2 : UCIP_FA_2016_21608_36662.jpg

View of pipe on waterward slope.

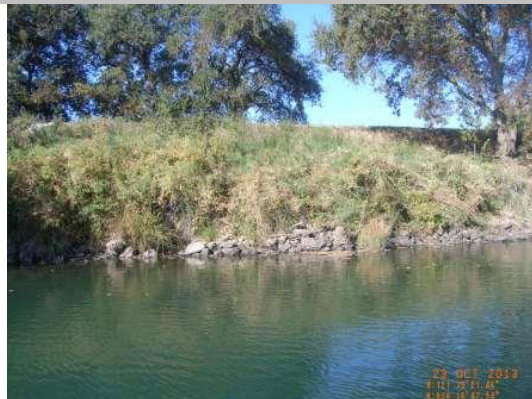
Photo 1 of 1 : FA_2016_RD0349_205_19_20160913_00012.jpg

LM Start	2.04	Rating **	M	Issue No.	19
LM End	2.05	Issue Type +	Ma	Location *	WS
Category	Supplemental			GPS Latitude/Longitude	
				Start	End
Item	2015 USACE Erosion Survey, DRAFT			38.280069 °	38.279919 °
				-121.589443 °	-121.589438 °
DWR ID	DWR_RD0349_02_s_2016_19				
Comment Code					
Inspector Comment					
2011 - Small scallop caused by erosion and wave wash. 2015: No observed changes. [2015 Site ID: STM_24-1_R]

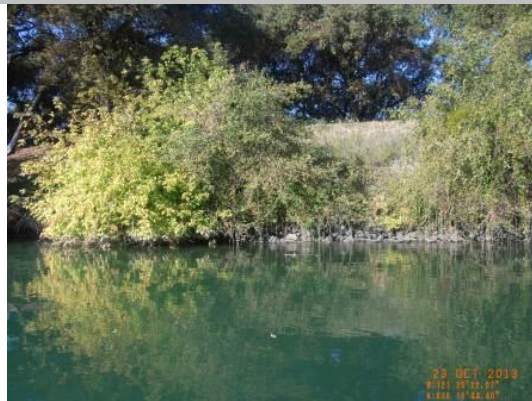
Photo 1 of 1 : FA_2016_RD0349_205_16_20160913_00011.jpg

LM Start	2.11	Rating **	M	Issue No.	16
LM End	2.14	Issue Type +	Ma	Location *	WS
Category	Supplemental			GPS Latitude/Longitude	
				Start	End
Item	2015 USACE Erosion Survey, DRAFT			38.279017 °	38.278597 °
				-121.589615 °	-121.589854 °
DWR ID	DWR_RD0349_02_s_2016_16				
Comment Code					
Inspector Comment					
1997 - Top right bank has retreated into the levee. Site is between two rock sites. 1999 - Downstream half of the reach repaired with rock. 2000 - Trees leaning into the water. 2010 - Site appears worse. 2011 - New erosion at the toe. 2013 - Short vertical sections observed at upstream end. 2015: Minor new erosion. [2015 Site ID: STM_23-9_R]

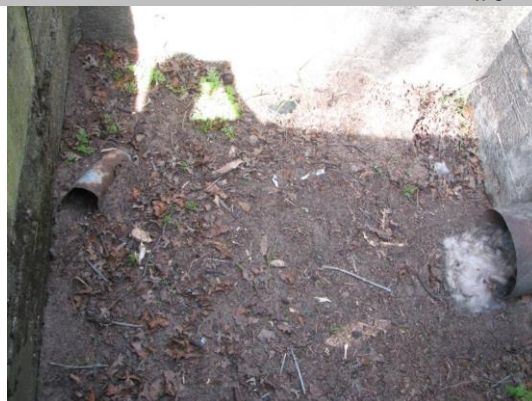
Photo 1 of 2 : UCIP_FA_2016_21609_36668.jpg

Inside view of distribution box located on landward side.

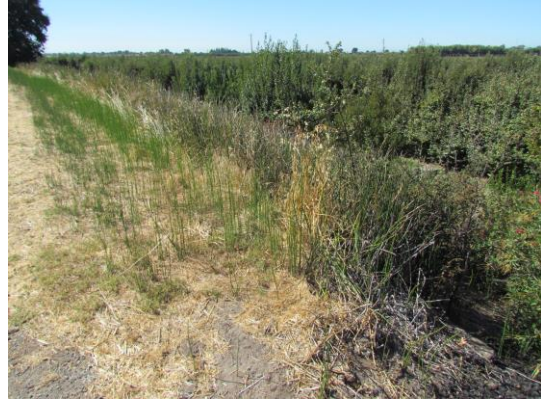
Photo 1 of 1 : FA_2016_RD0349_205_64_20161017_00091.jpg

LM Start	2.36	Rating **	U	Issue No.	64
LM End	4.30	Issue Type +	Ma	Location *	LS
Category	Earthen Levee			GPS Latitude/Longitude	
				Start	End
Item	Vegetation			38.275795 °	38.254703 °
				-121.591428 °	-121.599703 °
DWR ID	DWR_RD0349_02_s_2016_64				
Comment Code					
V2 : Remove the wild growth other than native grasses from the levee slopes.					
Inspector Comment					
The wild weeds on the landside slope and toe needs to be removed.

RD 349 Unit 2 looking downstream from levee mile 2.36 landside slope and toe.

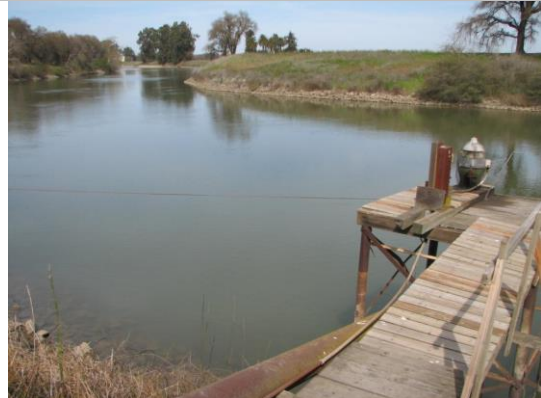
Photo 1 of 2 : UCIP_FA_2016_39873_36678.jpg

Comment Code					
Inspector Comment					
FS_ID:39873					
DS_ID:24158					
EP_NO: N/A					
Repair Type: Non-Urgent					
Crossing Status: Found					
UCIP Comments: Dense vegetation limit the inspector's visibility to identify signs of pipe failure (leaks) through the levee slopes.					
Recommend removing vegetation along pipe alignment to conduct proper inspection of structure and appurtenances.					
FIELD_STRUCT_DESC: 12-inch pipe through the levee, 4.0 feet below the crown. Pump on pile structure on waterward side, walkway to pump.					
Concrete distribution box and power pole with anchor at landward toe.					
Concrete standpipe on landward side. (Permit No. 946, 1944). This entry matches the Drainage or Irrigation Structure referenced in O&M manual (HLM 2.5).					
FS Date: 3/18/2009

View of waterward side--pump and control panel located on raised platform.

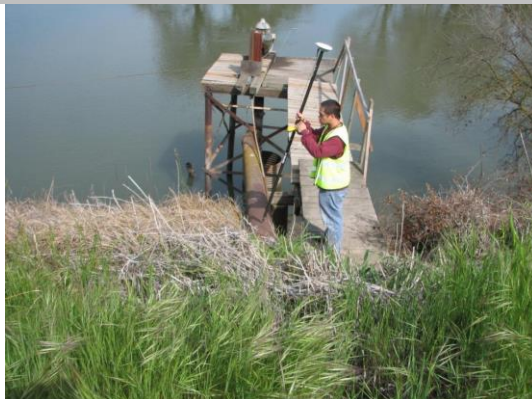
Photo 2 of 2 : UCIP_FA_2016_39873_36676.jpg

Comment Code						
Inspector Comment						
FS_ID:39873						
DS_ID:24158						
EP_NO: N/A						
Repair Type: Non-Urgent						
Crossing Status: Found						
UCIP Comments: Dense vegetation limit the inspector's visibility to identify signs of pipe failure (leaks) through the levee slopes.						
Recommend removing vegetation along pipe alignment to conduct proper inspection of structure and appurtenances.						
FIELD_STRUCT_DESC: 12-inch pipe through the levee, 4.0 feet below the crown. Pump on pile structure on waterward side, walkway to pump.						
Concrete distribution box and power pole with anchor at landward toe.						
Concrete standpipe on landward side. (Permit No. 946, 1944). This entry matches the Drainage or Irrigation Structure referenced in O&M manual (HLM 2.5).						
FS Date: 3/18/2009

Overview of waterward side--dense vegetation limits slope inspection.

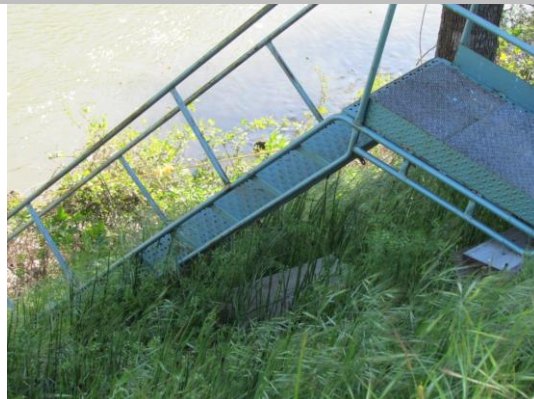
Photo 2 of 3 : FA_2016_RD0349_205_1_20160913_00002.jpg

LM Start	2.39	Rating **	U	Issue No.	1 (cont)	
LM End	2.39	Issue Type +	En	Location *	WS	
Category	Earthen Levee			GPS Latitude/Longitude		
				Start		End
Item	Encroachments			38.275403 °		38.275403 °
				-121.591229 °		-121.591229 °
DWR ID	DWR_RD0349_02_f_2013_1					
Comment Code						
ST : Stairway						
Inspector Comment						
The landowner has installed steps on the waterside slope and has an unauthorized boat dock anchored to the waterside slope.

Unauthorized metal steps on the waterside slope levee mile 2.39.

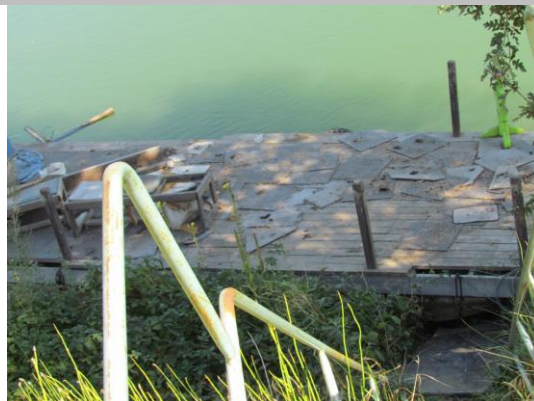
Photo 3 of 3 : FA_2016_RD0349_205_1_20161017_00093.jpg

Unauthorized dock at waterside toe.

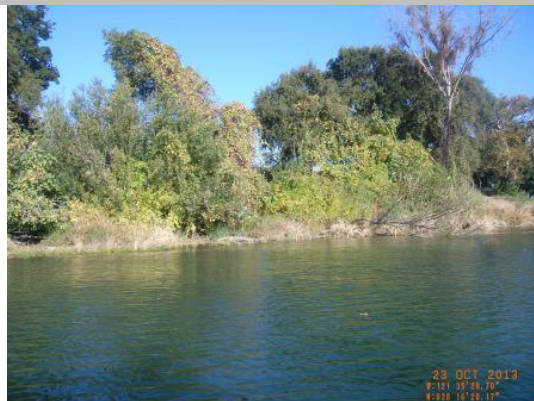
Photo 1 of 2 : FA_2016_RD0349_205_3_20160913_00003.jpg

LM Start	2.56	Rating **	M	Issue No.	3
LM End	2.69	Issue Type +	Ma	Location *	WS
Category	Supplemental			GPS Latitude/Longitude	
				Start	End
Item	2015 USACE Erosion Survey, DRAFT			38.273854 °	38.271998 °
				-121.588745 °	-121.589424 °
DWR ID	DWR_RD0349_02_s_2016_3				
Comment Code					
Inspector Comment					
2011 - Toe scour at the tidal zone. 2015: New tree popout and minor new erosion. [2015 Site ID: STM_23-6_R]

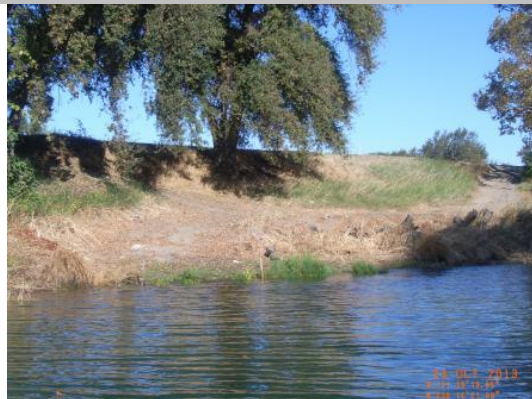
Photo 2 of 2 : FA_2016_RD0349_205_3_20160913_00004.jpg

LM Start	2.56	Rating **	M	Issue No.	3 (cont)	
LM End	2.69	Issue Type +	Ma	Location *	WS	
Category	Supplemental			GPS Latitude/Longitude		
				Start		End
Item	2015 USACE Erosion Survey, DRAFT			38.273854 °		38.271998 °
				-121.588745 °		-121.589424 °
DWR ID	DWR_RD0349_02_s_2016_3					
Comment Code						
Inspector Comment						
2011 - Toe scour at the tidal zone. 2015: New tree popout and minor new erosion. [2015 Site ID: STM_23-6_R]

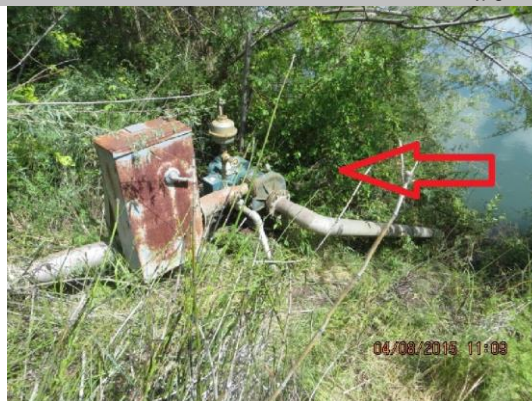
Photo 1 of 2 : UCIP_FA_2016_50015_73709.jpg

FS_ID:50015
DS_ID:24160
EP_NO: 655
Repair Type: Urgent
Crossing Status: Found
UCIP Comments: 8/17/2016 Dense vegetation limits the inspector's visibility to inspect levee section along pipe alignment. Previous inspection indicates holes visible on pipe wall. Need to contact owner to notify that pipe needs to be abandoned properly per Title 23 requirements. (DWR UCIP - omagana)4/8/2015 Pipe visible on WS slope and appears to be open. Pipe needs to be properly abandoned or verified as having been done so properly. (DWR UCIP - omagana)
FIELD_STRUCT_DESC: *ABANDONED* 6-inch steel pipe through the levee, 3.7 feet below the crown. Pump on concrete blocks on the waterside (WS) slope. 2-inch galvanized conduit is buried along side of the 6-inch pipe. PG&E service was installed on the landside (LS). (6-inch pipe authorized under Permit No. 5350, 1966 - Enver Salman, 6-inch pipe replaced previous 8-inch pipe authorized under Permit No. 655, 1935 - M. S. Salman) Unable to confirm if 8-inch pipe is the same pipe listed in the USACE O&M manual as HLM 3.2. [Additional Reference(s): DWR Levee Log, 2005. USACE San Joaquin O&M Manual Unit No. 110, May 1959, HLM 3.2, Drawing No. 50-4-3042].

Abandoned pipe visible on slope in vegetation behind new pipe on WS slope.

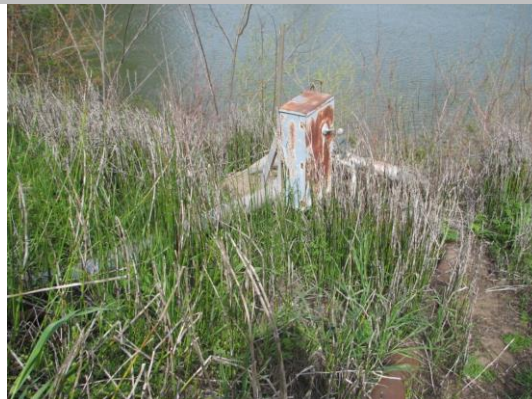
Photo 1 of 2 : UCIP_FA_2016_44332_36679.jpg

FS_ID:44332
DS_ID:24199
EP_NO: 5350
Repair Type: Non-Urgent
Crossing Status: Found
UCIP Comments: Need to contact owner to determine if crossing is still in use. If crossing is no longer in use owner will need to coordinate with DWR inspector and CVFPB to remove according to Title 23 requirements. Debris scattered on slopes--remove. Dense vegetation limits the inspector's visibility to identify signs of pipe failure (leaks) along the slope. Recommend removing vegetation along pipe alignment to conduct proper inspection of structure and appurtenances. Unable to determine if crossing is in use. Note date on photos should be 3/18/09 not 7/26/08 camera metadata is incorrect.
FIELD_STRUCT_DESC: 6-inch steel pipe and 2-inch iron electrical conduit through the levee, both 3.7 feet below the crown. Siphon breaker in pipe riser on waterward slope. Pump, switch panel, and butterfly valve on concrete blocks on the waterward slope. Service pole on landward slope (Permit No. 5350-1966).

View of waterward side--control panel, pipe, pump, and butterfly valve on WS slope.

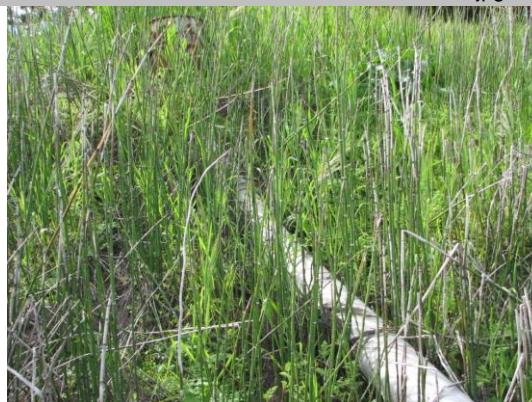
Photo 2 of 2 : UCIP_FA_2016_44332_36681.jpg

Pipe and Steel riser on WS slope.

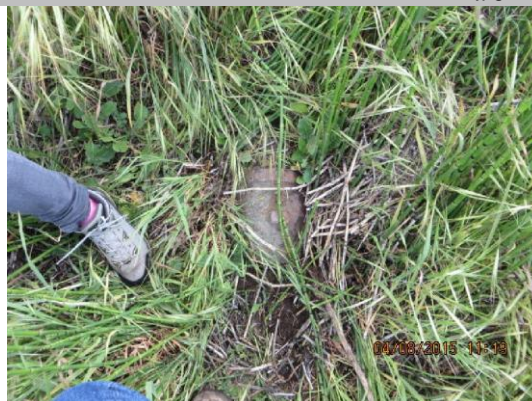
Photo 1 of 2 : UCIP_FA_2016_46172_74553.jpg

FS_ID:46172
DS_ID:25099
EP_NO: N/A
Repair Type: Non-Urgent
Crossing Status: Found
UCIP Comments: Appears abandoned and if so should be verified as having been done so properly.
FIELD_STRUCT_DESC: *ABANDONED* 6-inch pipe through the levee, 4.5 feet below the crown. Service pole at landward toe.
FS Date: 4/2/2015

Pipe just visible on LS slope.

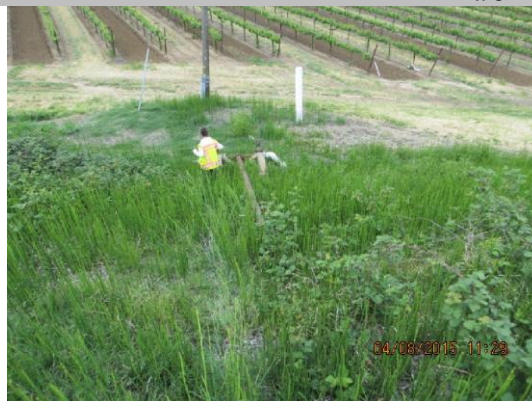
Photo 1 of 2 : UCIP_FA_2016_44333_73713.jpg

LM Start	3.31	Rating **	M	Issue No.	102
LM End	3.31	Issue Type +	En	Location *	LS
Category	Supplemental			GPS Latitude/Longitude	
				Start	End
Item	DWR UCIP Field Study			38.263359 °	38.263359 °
				-121.588721 °	-121.588721 °
DWR ID					
Comment Code					
Inspector Comment					
FS_ID:44333 DS_ID:24161 EP_NO: N/A Repair Type: Non-Urgent Crossing Status: Found UCIP Comments: Pipe appears abandoned and if so should be done so properly. FIELD_STRUCT_DESC: *ABANDONED* 6-inch pipe through the levee, 4.5 feet below the crown. Pump and switch panel on the waterward slope. Service pole and concrete distribution box at landward toe. (USACE-1959). This entry matches the Drainage or Irrigation Structure referenced in O&M manual (HLM 3.5). FS Date: 4/8/2015

Pipe, distribution box, and power pole visible on LS slope/toe.

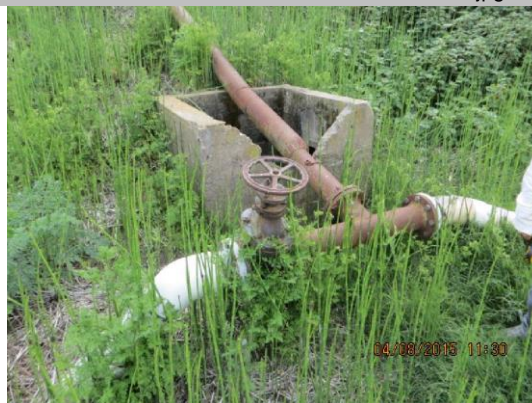
Photo 2 of 2 : UCIP_FA_2016_44333_73712.jpg

distribution box and pipe visible on LS toe.

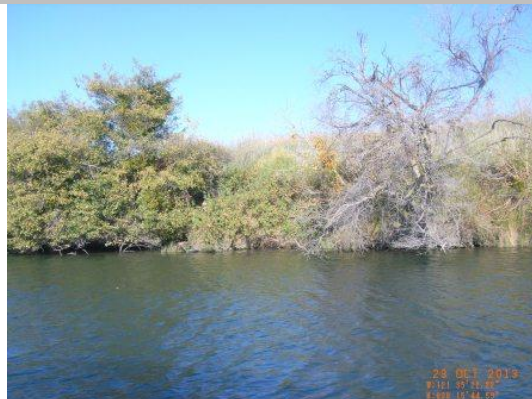
Photo 1 of 1 : FA_2016_RD0349_205_11_20160913_00009.jpg

LM Start	3.38	Rating **	M	Issue No.	11
LM End	3.49	Issue Type +	Ma	Location *	WS
Category	Supplemental			GPS Latitude/Longitude	
				Start	End
Item	2015 USACE Erosion Survey, DRAFT			38.262510 °	38.262533 °
				-121.589481 °	-121.591690 °
DWR ID	DWR_RD0349_02_s_2016_11				
Comment Code					
Inspector Comment					
2010 - Slumping sections on the lower bank, appears to be scouring around the trees. 2011 - Soil beach at toe. 2015: No observed changes. [2015 Site ID: STM_22-8_R]

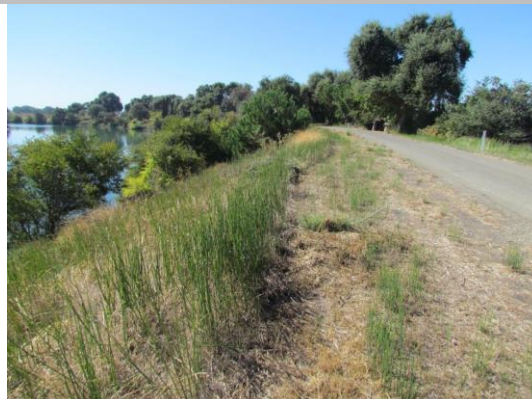
Photo 1 of 1 : FA_2016_RD0349_205_84_20160913_00022.jpg

Tall snap grasses covering the waterward slope.

LM Start	3.58	Rating **	U	Issue No.	84
LM End	4.31	Issue Type +	Ma	Location *	WS
Category	Earthen Levee			GPS Latitude/Longitude	
				Start	End
Item	Vegetation			38.262588 °	38.254733 °
				-121.593328 °	-121.599963 °
DWR ID	DWR_RD0349_02_f_2015_84				
Comment Code					
V2 : Remove the wild growth other than native grasses from the levee slopes.					
Inspector Comment					
Remove the snap grasses from the waterside levee slope.

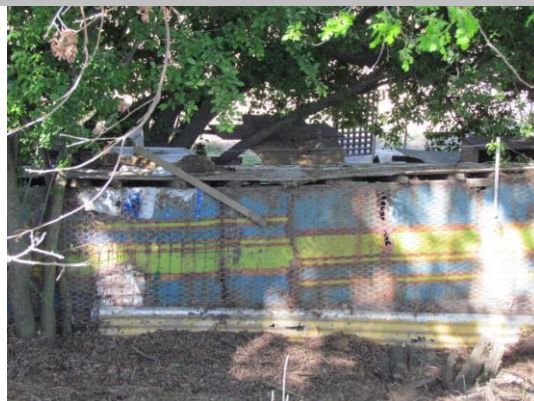
Photo 1 of 4 : FA_2016_RD0349_205_59_20160913_00016.jpg

LM Start	3.76	Rating **	U	Issue No.	59
LM End	3.91	Issue Type +	En	Location *	LS
Category	Earthen Levee			GPS Latitude/Longitude	
				Start	End
Item	Encroachments			38.260596 °	38.258426 °
				-121.592160 °	-121.595125 °
DWR ID	DWR_RD0349_02_f_2013_59				
Comment Code					
FE : Fence					
Inspector Comment					
Inside the fenced off area are several pet shelters and pens for chickens and goats on the landside levee slope and toe. This need to be taken off the levee section. In the event of a flood fight this area would cause delays in response time.

Unauthorized animal storage pens within the landside easement.

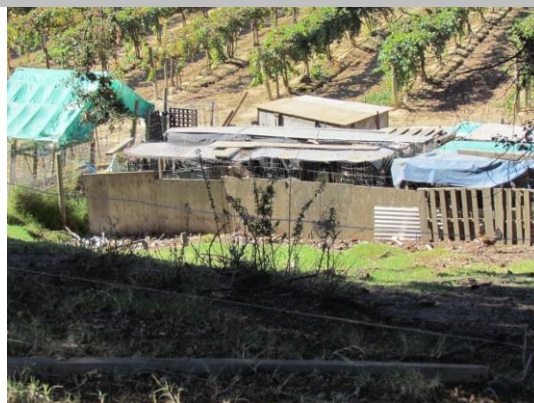
Photo 2 of 4 : FA_2016_RD0349_205_59_20160913_00017.jpg

Unauthorized electric wire fence, solid board fence and animal storages within the 10-foot easement landside levee toe.

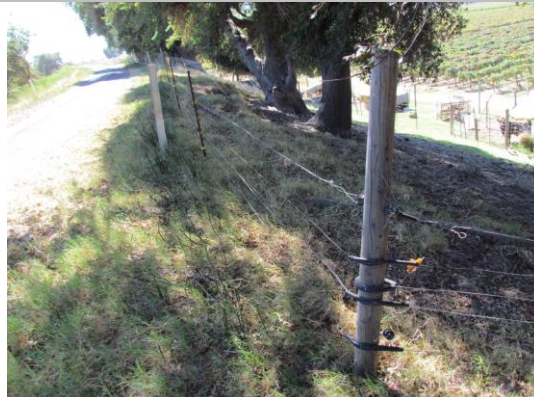
Photo 4 of 4 : FA_2016_RD0349_205_59_20161017_00095.jpg

LM Start	3.76	Rating **	U	Issue No.	59 (cont)	
LM End	3.91	Issue Type +	En	Location *	LS	
Category	Earthen Levee			GPS Latitude/Longitude		
				Start		End
Item	Encroachments			38.260596 °		38.258426 °
				-121.592160 °		-121.595125 °
DWR ID	DWR_RD0349_02_f_2013_59					
Comment Code						
FE : Fence						
Inspector Comment						
Inside the fenced off area are several pet shelters and pens for chickens and goats on the landside levee slope and toe. This need to be taken off the levee section. In the event of a flood fight this area would cause delays in response time.

Unauthorized electric fence installed along the shoulder and levee slope.

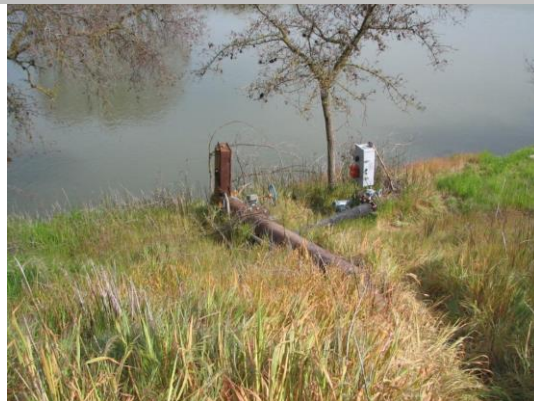
Photo 1 of 2 : UCIP_FA_2016_21612_36684.jpg

Comment Code					
Inspector Comment					
FS_ID:21612					
DS_ID:24162					
EP_NO: 8188					
Repair Type: Non-Urgent					
Crossing Status: Found					
UCIP Comments: Dense vegetation limits the inspector's visibility to identify signs of pipe failure (leaks) along the landward slope. Recommend removing vegetation along pipe alignment to conduct proper inspection of structure and appurtenances. Unable to determine if crossing is in use. Note date on photos should be 3/18/09 not 7/26/08 camera metadata is incorrect.					
FIELD_STRUCT_DESC: 12-inch steel irrigation pipe and 1.25-inch electrical conduit through the levee, both 5.0 feet below the crown. Steel cutoff wall around pipe at center of levee. Siphon breaker on shoulder. Pump and pumphouse on the waterward side. Service pole, discharge box and concrete standpipe at landward toe. (Permit No. 8188-1973)					
FS Date: 3/18/2009

Overview of waterward side--2 crossings.

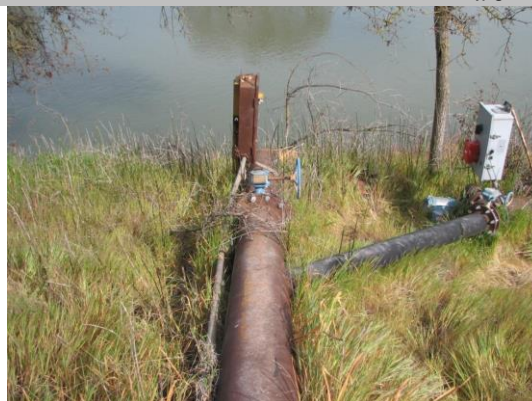
Photo 2 of 2 : UCIP_FA_2016_21612_36682.jpg

Comment Code					
Inspector Comment					
FS_ID:21612 DS_ID:24162 EP_NO: 8188 Repair Type: Non-Urgent Crossing Status: Found UCIP Comments: Dense vegetation limits the inspector's visibility to identify signs of pipe failure (leaks) along the landward slope. Recommend removing vegetation along pipe alignment to conduct proper inspection of structure and appurtenances. Unable to determine if crossing is in use. Note date on photos should be 3/18/09 not 7/26/08 camera metadata is incorrect. FIELD_STRUCT_DESC: 12-inch steel irrigation pipe and 1.25-inch electrical conduit through the levee, both 5.0 feet below the crown. Steel cutoff wall around pipe at center of levee. Siphon breaker on shoulder. Pump and pumphouse on the waterward side. Service pole, discharge box and concrete standpipe at landward toe. (Permit No. 8188-1973) FS Date: 3/18/2009

View of crossing on waterward side.

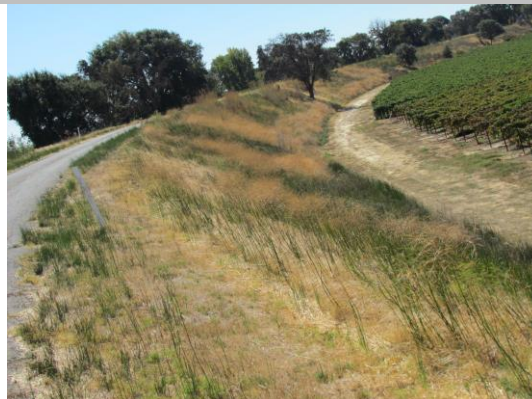
Photo 1 of 1 : FA_2016_RD0349_205_40_20161017_00094.jpg

LM Start	3.94	Rating **	U	Issue No.	40
LM End	4.31	Issue Type +	Ma	Location *	LS
Category	Earthen Levee			GPS Latitude/Longitude	
				Start	End
Item	Vegetation			38.258062 °	38.254715 °
				-121.595153 °	-121.599900 °
DWR ID	DWR_RD0349_02_f_2016_40				
Comment Code					
V1 : Control annual grass and weeds on the levee slopes and easements.					
Inspector Comment					
Control the wild vegetation growth on the landside levee slope.

RD 349 Unnit 2 levee mile 3.94-4.31 looking downstream.

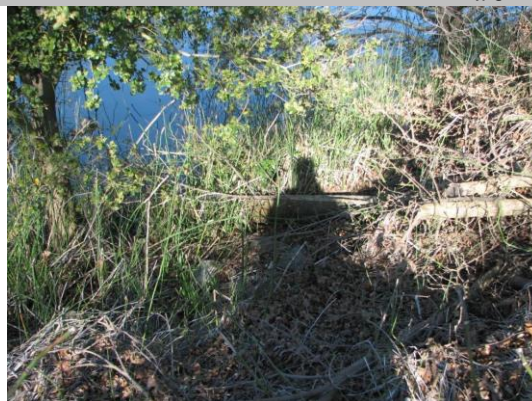
Photo 1 of 2 : UCIP_FA_2016_43442_36707.jpg

Comment Code					
Inspector Comment					
FS_ID:43442					
DS_ID:24163					
EP_NO: N/A					
Repair Type: Non-Urgent					
Crossing Status: Found					
UCIP Comments: Need to find owner and notify of pipe deterioration.					
Owner will need to replace or remove per CVFPB Title 23 requirements.					
Dense vegetation limits the inspector's visibility to identify signs of pipe failure (leaks) through the levee slopes. Recommend removing					
vegetation along pipe alignment to conduct proper inspection of					
structure and appurtenances. Note date on photos should be 3/18/09					
not 7/26/08 camera metadata is incorrect.					
FIELD_STRUCT_DESC: 8-inch steel irrigation pipe through the levee,

2.4 feet below the crown. Pump and gate valve in a pumphouse at the					
landward toe. Concrete standpipe on landward side.					
FS Date: 3/19/2009

View of waterward side--portion of pipe exposed on slope.

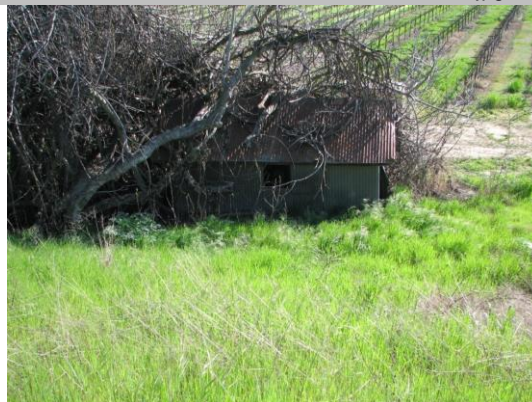
Photo 2 of 2 : UCIP_FA_2016_43442_36706.jpg

Pump house located at the landward toe.

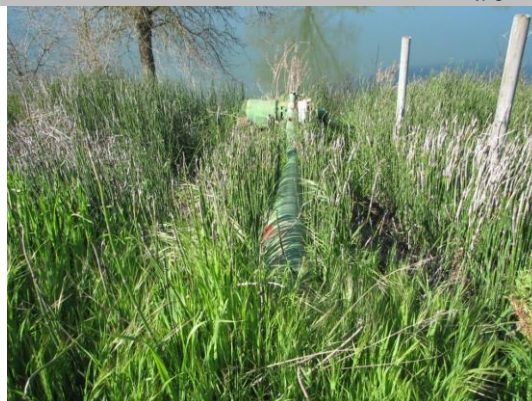
Photo 1 of 2 : UCIP_FA_2016_21673_36851.jpg

FS_ID:21673
DS_ID:24232
EP_NO: N/A
Repair Type: Non-Urgent
Crossing Status: Found
UCIP Comments: No records were found during initial desk study--need to contact owner to obtain permit number authorizing work. Unable to determine if filter system is part of crossing appurtenances. If crossing is no longer used by owner, the owner will need to coordinate with DWR Inspector and CVFPB to remove crossing according to Title 23 requirements. Dense vegetation limits the inspector's visibility to identify signs of pipe failure (leaks) through the levee slopes. Recommend removing vegetation along pipe alignment to conduct proper inspection of structure and appurtenances. Note date on photos should be 3/18/09 not 7/26/08 camera metadata is incorrect.
FIELD_STRUCT_DESC: 12-inch pipe through the levee, approximately 2.0 feet below the crown. Pipe changes diameter, 10-inch along both shoulders and 8-inch diameter exit on waterward side. Pipe exposed along both slopes. Pump on waterward side. Filtration system and power pole on landward side. Rock revetment on waterward slope.

View of waterward side--pipe and pump.

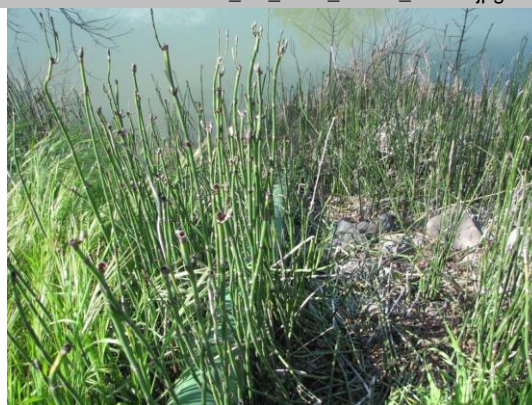
Photo 2 of 2 : UCIP_FA_2016_21673_36853.jpg

View of pipe crossing past pump station.

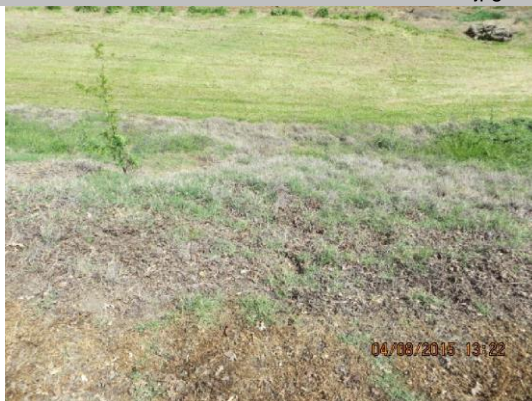
Photo 1 of 2 : UCIP_FA_2016_44335_73721.jpg

LM Start	1.17	Rating **	M	Issue No.	986
LM End	1.17	Issue Type +	En	Location *	WS
Category	Supplemental			GPS Latitude/Longitude	
				Start	End
Item	DWR UCIP Field Study			38.271218 °	38.271218 °
				-121.603468 °	-121.603468 °
DWR ID					
Comment Code					
Inspector Comment					
FS_ID:44335					
DS_ID:24166					
EP_NO: N/A					
Repair Type: Non-Urgent					
Crossing Status: Found					
UCIP Comments: Pipe abandoned and should be done so properly or verified as having been done so properly.					
FIELD_STRUCT_DESC: 6-inch pipe through the levee, 4.5 feet below the crown. Pump and pumphouse no longer on the landward toe. (USACE-1959). This entry matches the Drainage or Irrigation Structure referenced in O&M manual (HLM 1.2).					
FS Date: 4/9/2015

Pipe visible on LS slope.

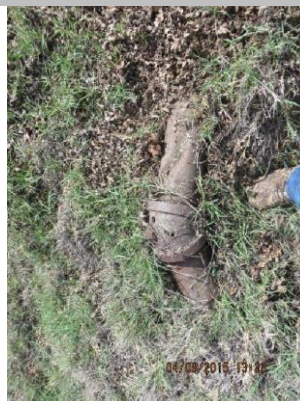
Photo 2 of 2 : UCIP_FA_2016_44335_73720.jpg

LM Start	1.17	Rating **	M	Issue No.	986 (cont)	
LM End	1.17	Issue Type +	En	Location *	WS	
Category	Supplemental			GPS Latitude/Longitude		
				Start	End	
Item	DWR UCIP Field Study			38.271218 °	38.271218 °	
				-121.603468 °	-121.603468 °	
DWR ID						
Comment Code						
Inspector Comment						
FS_ID:44335						
DS_ID:24166						
EP_NO: N/A						
Repair Type: Non-Urgent						
Crossing Status: Found						
UCIP Comments: Pipe abandoned and should be done so properly or verified as having been done so properly.						
FIELD_STRUCT_DESC: 6-inch pipe through the levee, 4.5 feet below the crown. Pump and pumphouse no longer on the landward toe.						
(USACE-1959). This entry matches the Drainage or Irrigation Structure referenced in O&M manual (HLM 1.2).						
FS Date: 4/9/2015

Pipe visible on LS slope.

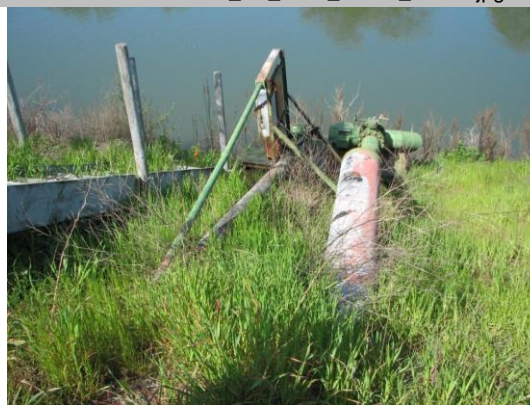
Photo 1 of 1 : UCIP_FA_2016_47043_36864.jpg

Comment Code					
Inspector Comment					
FS_ID:47043 DS_ID:24169 EP_NO: 11744 Repair Type: Non-Urgent Crossing Status: Found UCIP Comments: Dense vegetation limits the inspector's visibility to identify signs of pipe failure (leaks) through the levee slopes. Recommend removing vegetation along pipe alignment to conduct proper inspection of structure and appurtenances. Note date on photos should be 3/18/09 not 7/26/08 camera metadata is incorrect. FIELD_STRUCT_DESC: 1 of 2: 8-inch pipe through the levee, 3.7 feet below the crown. 8-inch pipe is reduced to 3-inch pipe on waterward side. Steel cutoff wall around pipe at center of levee. Siphon breaker at landward shoulder. Siphon breaker at landward shoulder. Slant pump on waterward side. Discharge structure at landward toe. Rock revetment on waterward slope. (Permit No. 11744-1976) FS Date: 3/19/2009

View of pipe, control panel, and stairs. 2 pipes go through levee 14-inch and 8-inch.

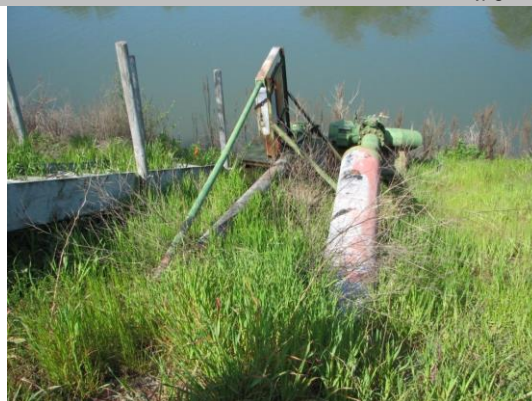
Photo 1 of 2 : UCIP_FA_2016_47042_36856.jpg

FS_ID:47042
DS_ID:24168
EP_NO: 11744
Repair Type: Non-Urgent
Crossing Status: Found
UCIP Comments: Dense vegetation limits the inspector's visibility to identify signs of pipe failure (leaks) through the levee slopes. Recommend removing vegetation along pipe alignment to conduct proper inspection of structure and appurtenances. Note date on photos should be 3/18/09 not 7/26/08 camera metadata is incorrect.
FIELD_STRUCT_DESC: 2 of 2: 14-inch steel irrigation pipe and 2-inch electric conduit through the levee, both 4.4 feet below the crown. Reduced to 12-inch steel pipe under both levee slopes. Steel cutoff wall around pipe at center of levee. Siphon breaker at landward shoulder. Slant pump on waterward side with staircase access. Discharge structure at landward toe. Rock revetment on waterward slope. (Permit No. 11744-1976)
FS Date: 3/19/2009

Pump system located on waterward side.

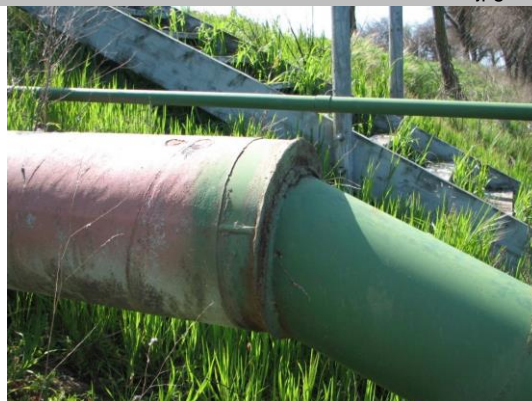
Photo 2 of 2 : UCIP_FA_2016_47042_36857.jpg

Pipe reduced from 14-inch to 10-inch and conduit through levee.

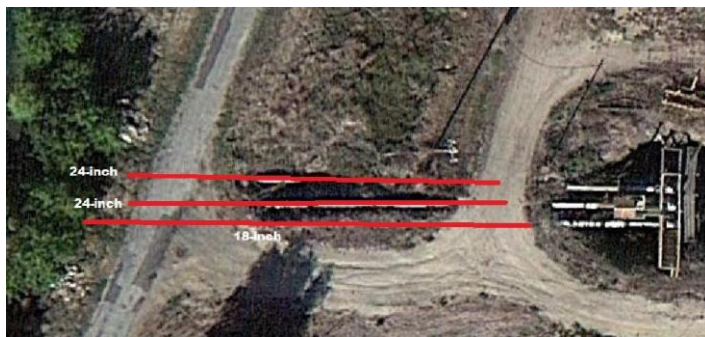
Photo 1 of 2 : UCIP_FA_2016_43446_36725.jpg

LM Start	1.49	Rating **	M	Issue No.	978
LM End	1.49	Issue Type +	En	Location *	WS
Category	Supplemental			GPS Latitude/Longitude	
				Start	End
Item	DWR UCIP Field Study			38.275532 °	38.275532 °
				-121.601225 °	-121.601225 °
DWR ID					
Comment Code					
Inspector Comment					
FS_ID:43446					
DS_ID:24229					
EP_NO: 2954					
Repair Type: Non-Urgent					
Crossing Status: Found					
UCIP Comments: Dense vegetation limits the inspector's visibility to					
proper inspection of structure and appurtenances. Note date on photos					
should be 3/18/09 not 7/26/08 camera metadata is incorrect.					
FIELD_STRUCT_DESC: [R.D. No. 349 Drainage Pumping Plant] 1 of 3:					
18-inch pipe through the levee, 7.8 feet below the crown. Siphon					
breakers on waterward slope. Pumps on platform on landward side.					
FS Date: 3/19/2009

Aerial map showing alignment of 18-inch pipe.

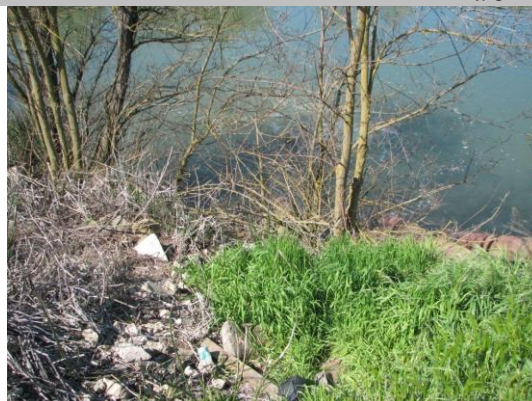
Photo 2 of 2 : UCIP_FA_2016_43446_36726.jpg

Item	DWR UCIP Field Study			38.275532 °	38.275532 °	
				-121.601225 °	-121.601225 °	
DWR ID						
Comment Code						
Inspector Comment						
FS_ID:43446						
DS_ID:24229						
EP_NO: 2954						
Repair Type: Non-Urgent						
Crossing Status: Found						
UCIP Comments: Dense vegetation limits the inspector's visibility to identify signs of pipe failure (leaks) through the levee slopes.						
Recommend removing vegetation along pipe alignment to conduct proper inspection of structure and appurtenances. Note date on photos should be 3/18/09 not 7/26/08 camera metadata is incorrect.						
FIELD_STRUCT_DESC: [R.D. No. 349 Drainage Pumping Plant] 1 of 3: 18-inch pipe through the levee, 7.8 feet below the crown. Siphon breakers on waterward slope. Pumps on platform on landward side.						
FS Date: 3/19/2009

View of all 3 pipes through levee and visible on waterward toe.

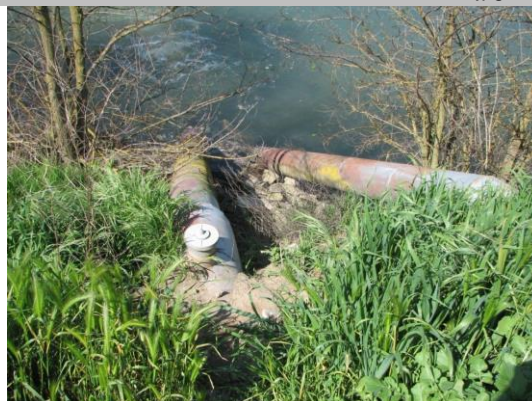
Photo 2 of 2 : UCIP_FA_2016_43445_36727.jpg

Item	DWR UCIP Field Study			38.275546 °		38.275546 °
				-121.601218 °		-121.601218 °
DWR ID						
Comment Code						
Inspector Comment						
FS_ID:43445 DS_ID:24228 EP_NO: 2954 Repair Type: Non-Urgent Crossing Status: Found UCIP Comments: Dense vegetation limits the inspector's visibility to identify signs of pipe failure (leaks) along the slope. Recommend removing vegetation along pipe alignment to conduct proper inspection of structure and appurtenances. Note date on photos should be 3/18/09 not 7/26/08 camera metadata is incorrect. FIELD_STRUCT_DESC: [R.D. No. 349 Drainage Pumping Plant] 2 of 3: 24-inch pipe through the levee, 7.8 feet below the crown. Siphon breakers on waterward slope. Pumps on platform on landward side. FS Date: 3/19/2009

View of pipe on waterward side--pipe running. Siphon breaker visible on pipe.

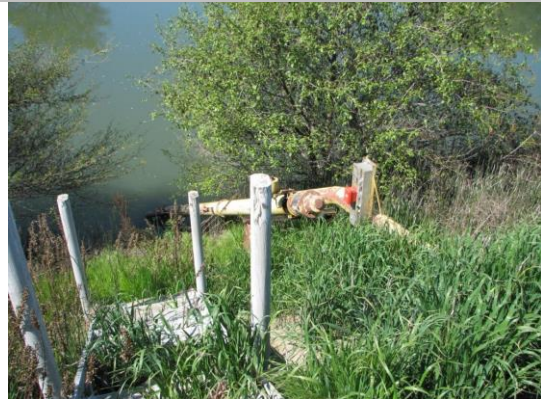
Photo 1 of 2 : UCIP_FA_2016_47045_36736.jpg

Comment Code					
Inspector Comment					
FS_ID:47045					
DS_ID:24172					
EP_NO: N/A					
Repair Type: Non-Urgent					
Crossing Status: Found					
UCIP Comments: Dense vegetation limits the inspector's visibility to identify signs of pipe failure (leaks) through the levee slopes.					
Recommend removing vegetation along pipe alignment to conduct proper inspection of structure and appurtenances. Note date on photos should be 3/18/09 not 7/26/08 camera metadata is incorrect.					
FIELD_STRUCT_DESC: 1 of 2: 12-inch pipe and 2-inch electrical conduit through the levee, both 8.0 feet below the crown. Siphon breaker in pipe riser on landward slope. Concrete standpipe at landward toe. Pump on waterward side with stairway access.					
FS Date: 3/19/2009

View of waterward side--pump, pipe, control panel, and stairway.
